**PROPOSED PLAN  
THIRD EXPLANATION OF SIGNIFICANT  
DIFFERENCES  
for the  
JOHNS-MANVILLE SITE  
WAUKEGAN, ILLINOIS**

**Appendix  
Blanding's Turtle Conservation Plan**

**Johns Manville  
1871 North Pershing Road  
Waukegan, Illinois 60087**

**Revision 1  
March 25, 2005**

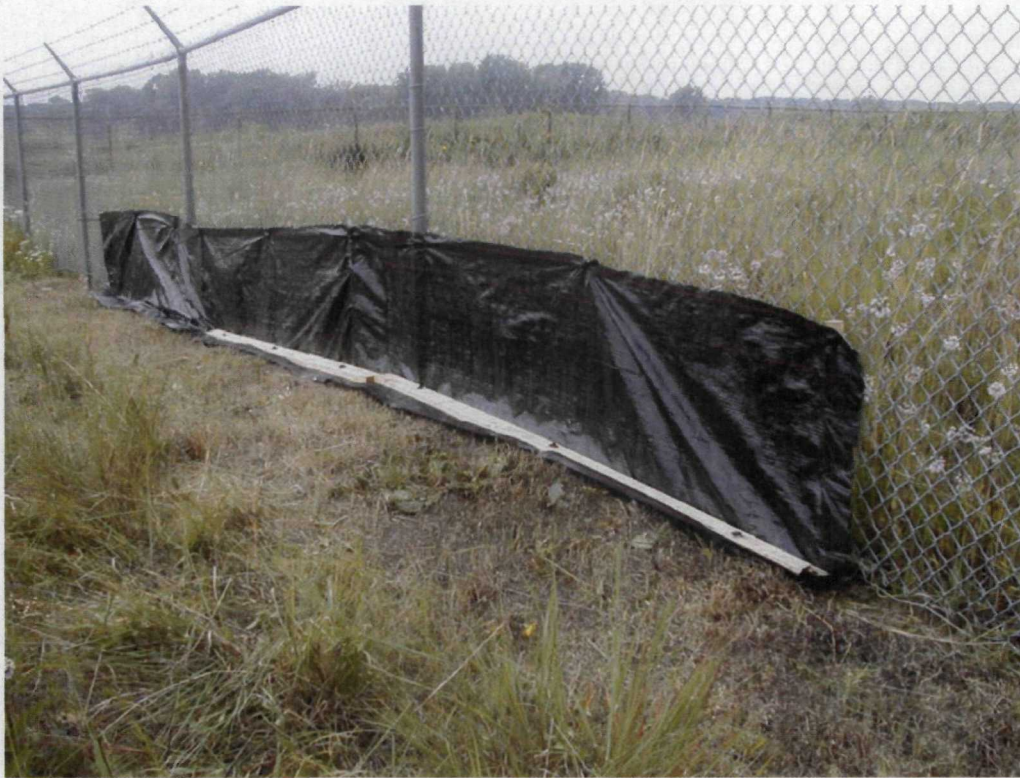
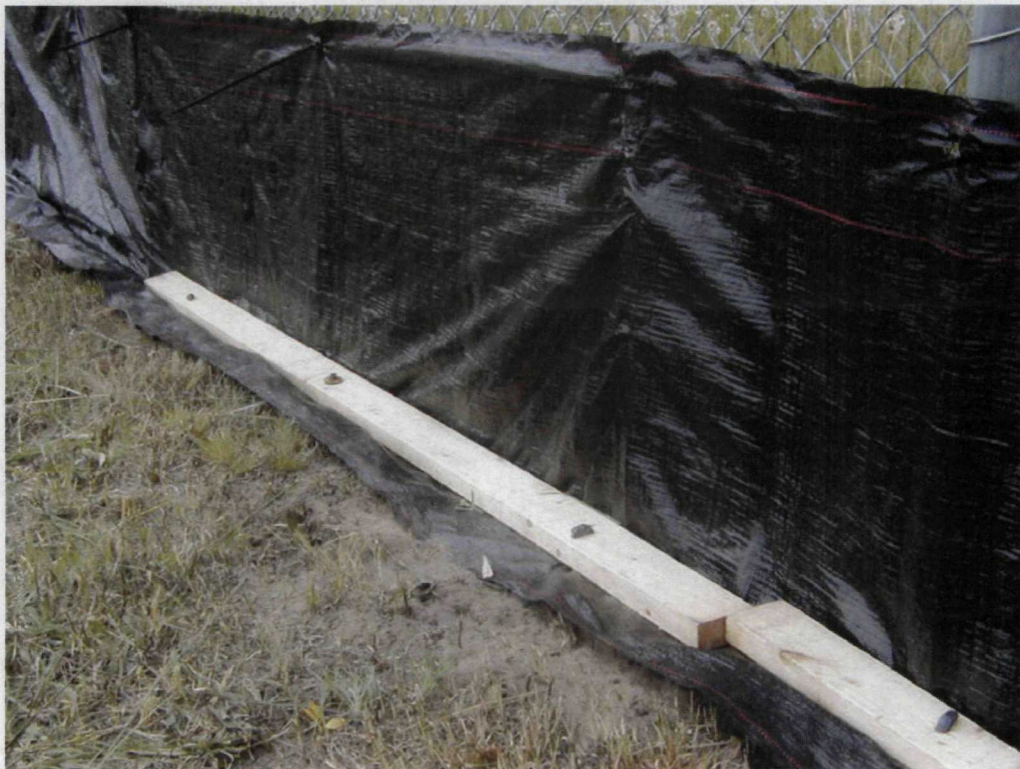
### **Example Photos of Fence Blockage**

Example Fence Blockage using Silt Fencing

- Where there was no expectation that surface water would flow beneath the fenceline in any appreciable volume (*e.g.*, not a pre-existing swale), gaps in the bottom of the fenceline were closed by attaching silt fencing to the existing chain-link fence and anchoring it to the ground using a board and ground spikes. The photographs in Attachment 1 are examples of how this system was constructed. A gap was blocked if the bottom of the existing fence was more than one-half inch above the ground surface.
